Monitoring Data Record

Project Title: R-2248BB – Charlotte Outer Loop COE Action ID: 200131321
 Stream Name: UT Thomas Pond (Site 9) DWQ Number: 011231
 City, County and other Location Information: Mecklenburg County, Charlotte Outer Loop, NC 27 Exit (Mount Holly Road)
 Date Construction Completed: April 2005 Monitoring Year: (5) of 5
 Ecoregion: _____ 8 digit HUC unit 03050101
 USGS Quad Name and Coordinates: _____

This completes the Year 5 Summer evaluation for the UT Thomas Pond stream mitigation site. Overall, the channel is stable.

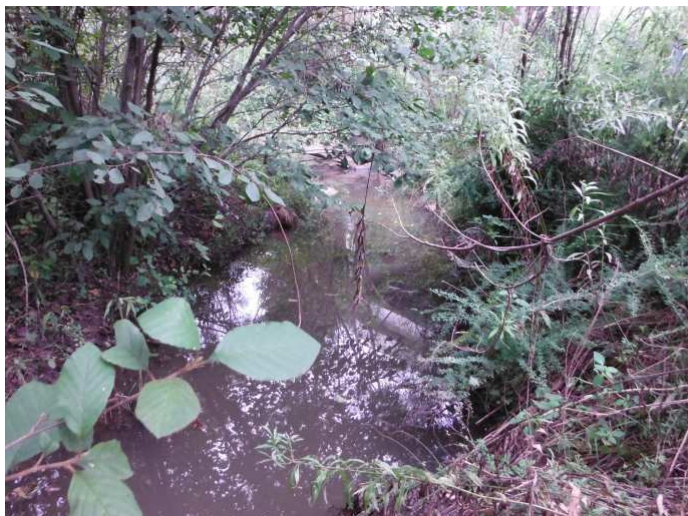
Photo Point #1 (Upstream)

| Date 9/11/12 | Station Number 217+80 –L- (PP#1 Upstream) | Station Number 219+00-L- | Station Number | Station Number | Station Number |
| Is water piping through or around structure? | Water piping under crossvane | | | | |

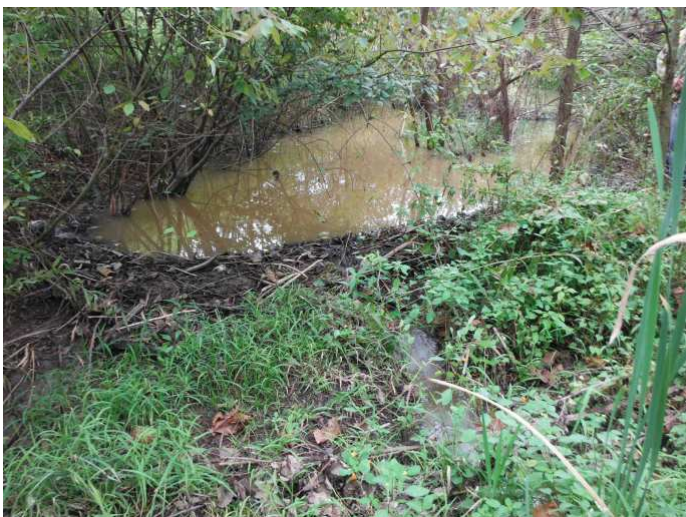
During the Sept. 2012 monitoring evaluation, a series of small beaver dams (see additional photos) were noted throughout this stream mitigation site. NCDOT will contact USDA to trap the beavers from this stream mitigation site. There have been four bankfull events visually documented over the 5- year monitoring period. NCDOT has completed five years of monitoring evaluations and proposes to discontinue monitoring this stream mitigation site for channel stability.

Beaver dam b/t PP#2 and PP#3

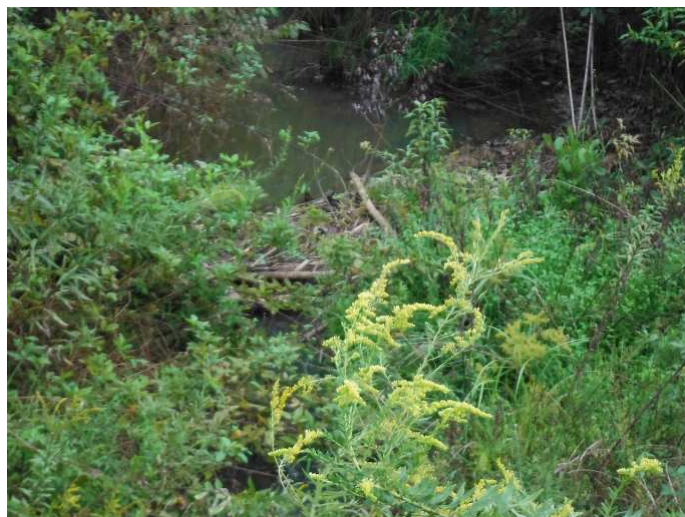
Beaver dam b/t PP#3 and culvert inlet @ I-485

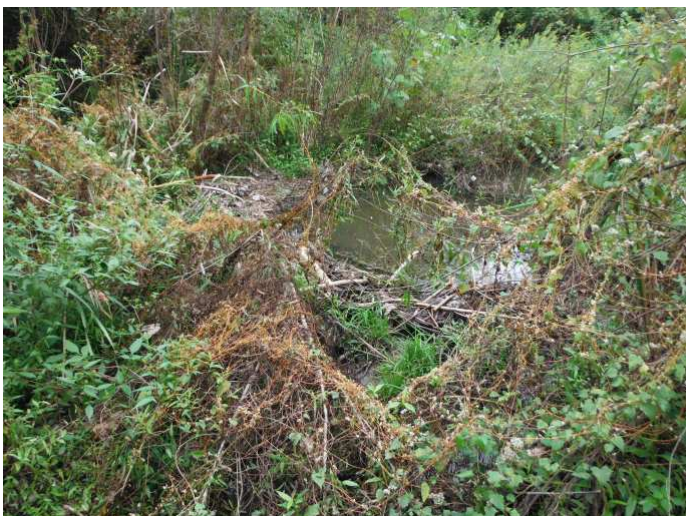
Beaver dam b/t culvert outlet @ I-485 and PP#4
Year 5 Summer – September 2012

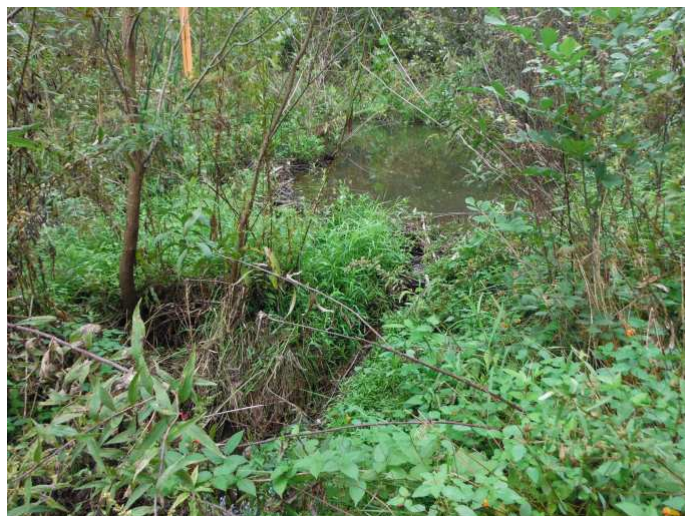
Beaver dam b/t PP#4 and PP#5

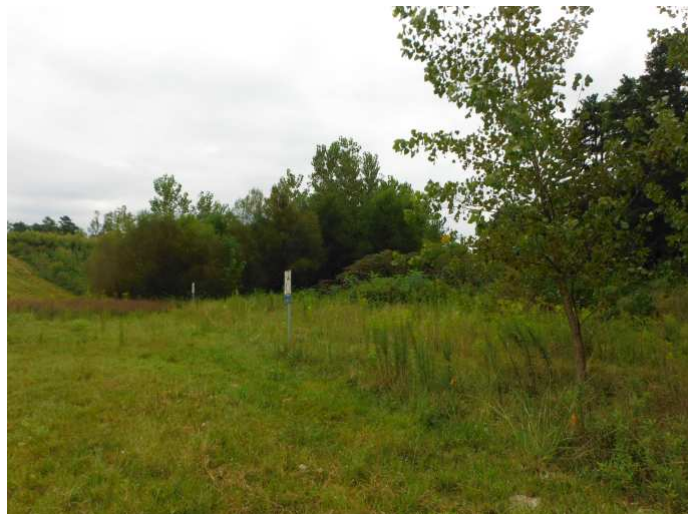
Replanted buffer that was previously mowed inside Loop E
